FORMED SEALANT GROOVE DETAIL

TYPICAL CRACK REPAIR DETAIL

<p>EASTERN MUNICIPAL WATER DISTRICT</p>	
Δ	3/12/01	GR	REVISED FILE ID NO						
REFERENCES: SUPERCEDES A-533				SCALE: NONE				<p>APPROVED <i>James H. Burt Jr.</i> 4/8/87</p> <p>ASSISTANT GENERAL MANAGER ENGINEERING DATE</p>	
FILE I.D.: m:\graph\oa\water\maint\standard.dwg\B-666.dgn				DRAWN BY CRD					
								B-666

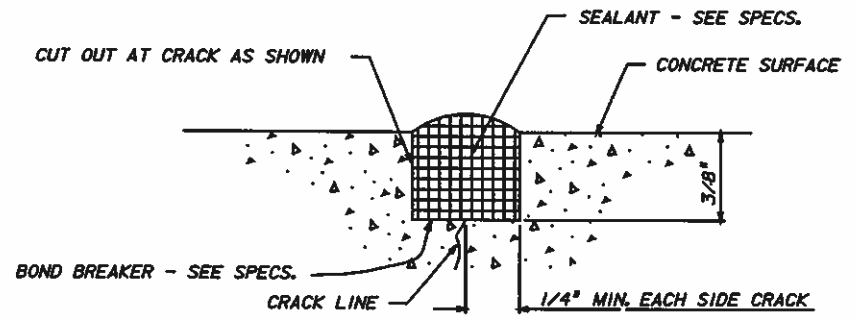
NOTE: PRIOR TO FILLING STRUCTURE WITH WATER REPAIR ALL CRACKS IN FLOOR SLABS, WALLS, AND ROOF SLAB AS PER DETAIL ABOVE.
